12913AAC

Steel Reverse Servo Pin

A904 • A727 • A518 • A618

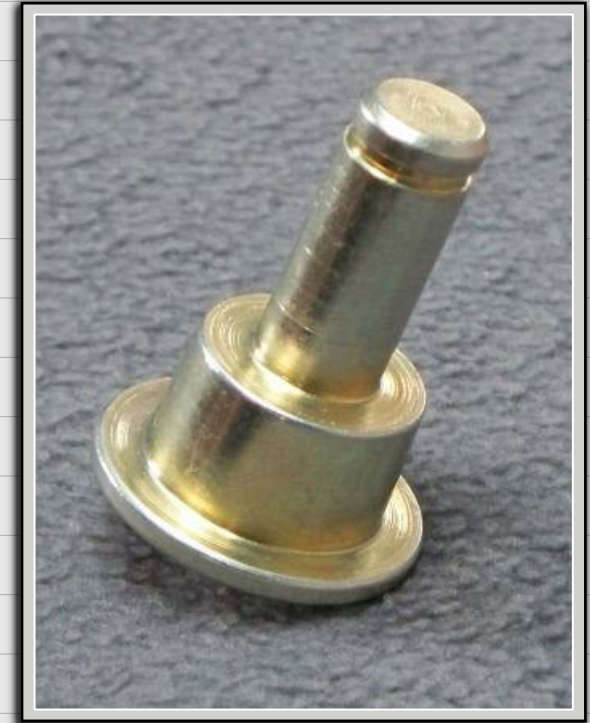
Rear wheel drive Chrysler transmissions have long had durability problems of their soft aluminum reverse servo pins. OEM pins are susceptible to galling; the resulting pressure loss eventually ends in band failure. Sometimes piston wear allows side-loading that can snap the OEM aluminum versions.

We're introducing a solid solution with our precision milled steel **#12913AAC**. Gold anodized for enhanced durability, this pin will hold up to what working trucks can hand out.
